U.S. Department of Transportation

**Public Forum Meeting
August 8, 2000**

US DOT Office of Pipeline Safety Actions

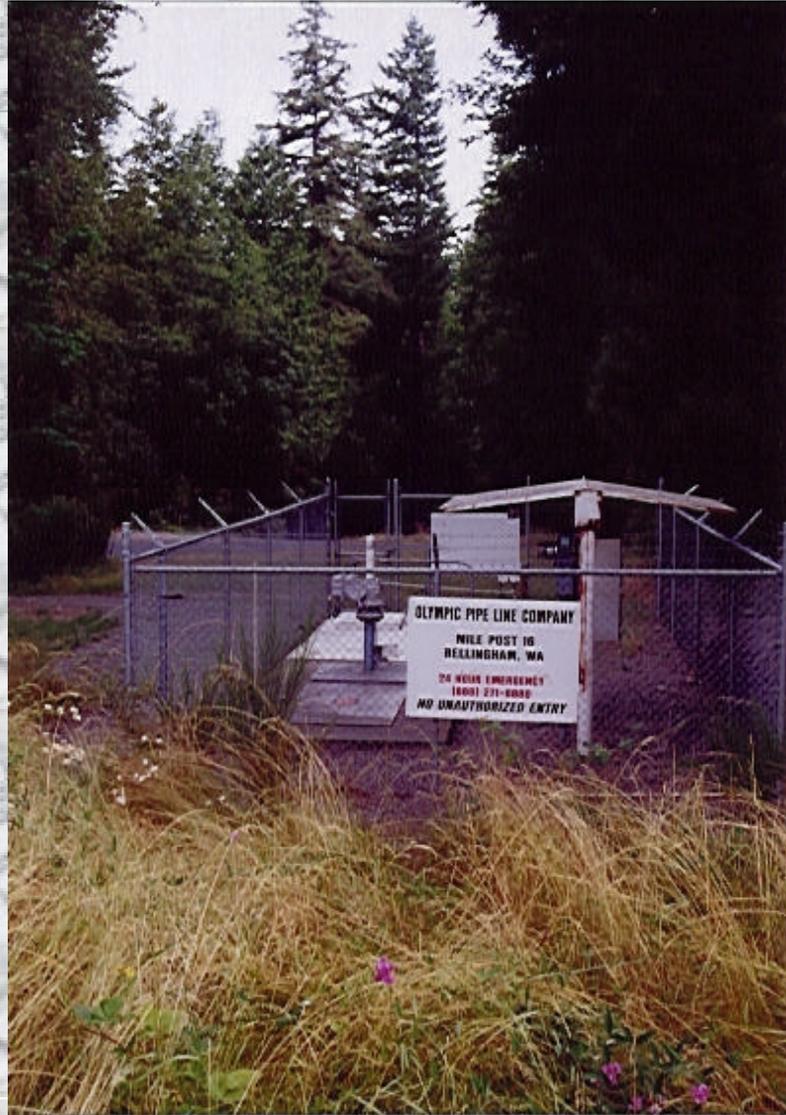
- MP 16
Remote
Control
Block Valve
and New
Check Valve
Lakeway Dr.

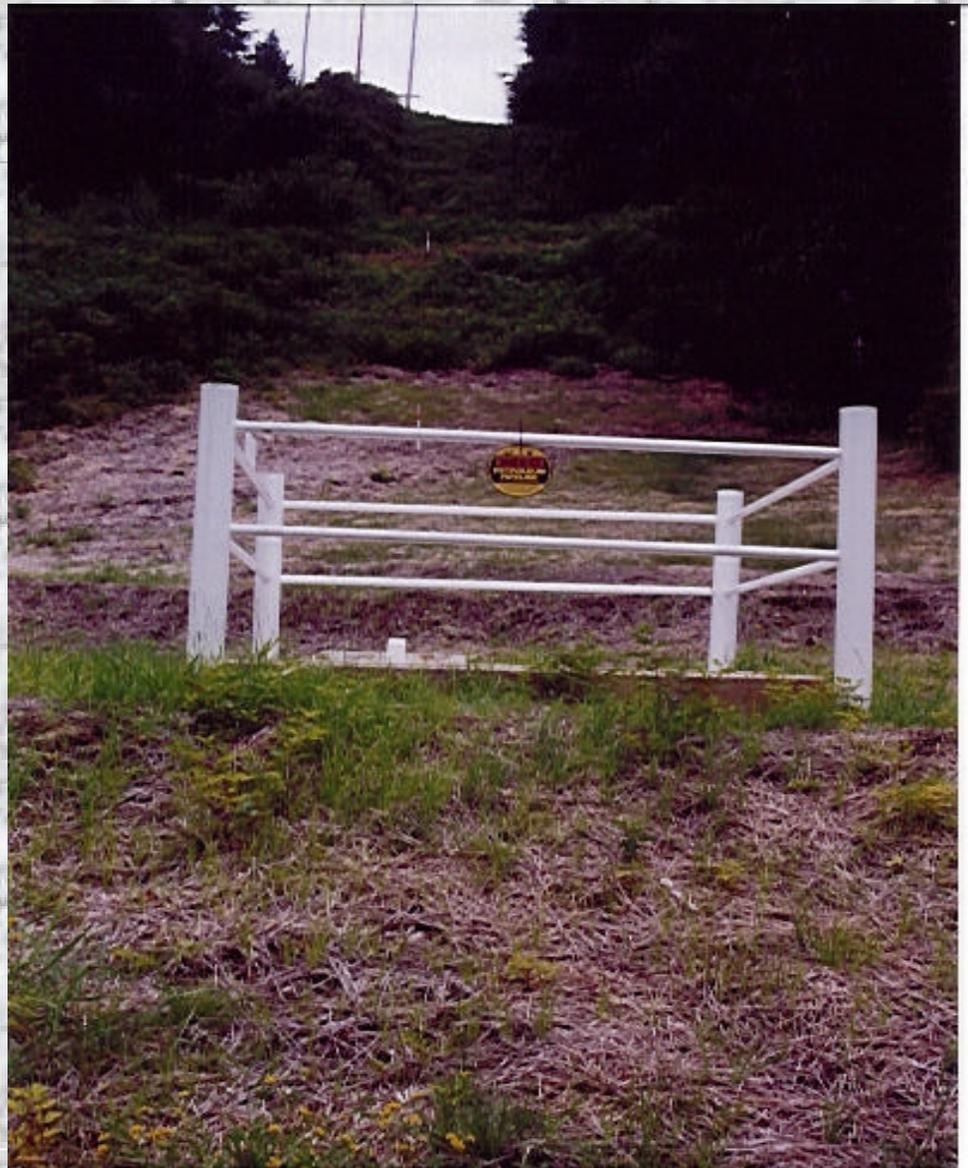
- New Check Valve at Milepo st 21
- N. Lake Samish

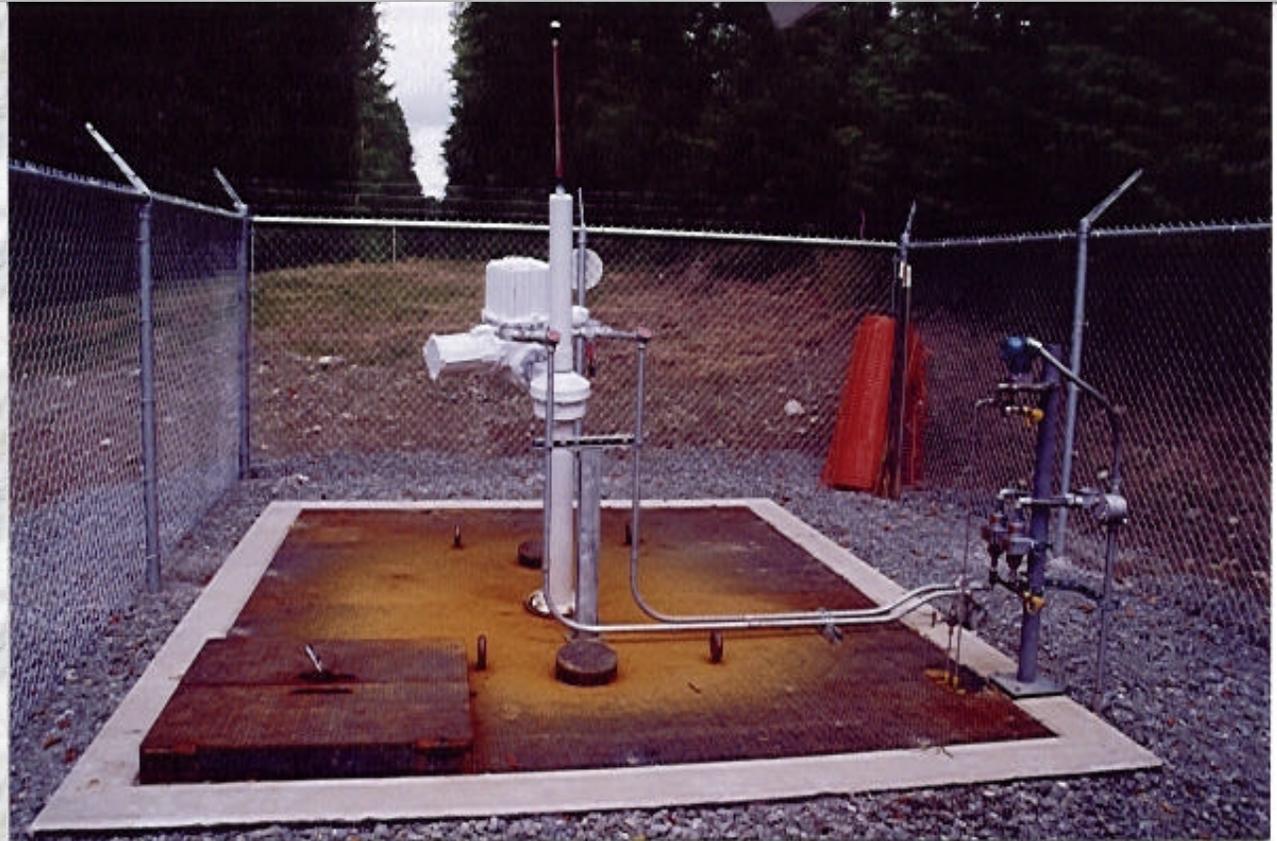
- Remote Control of Existing Valve at MP 28

- New Vault

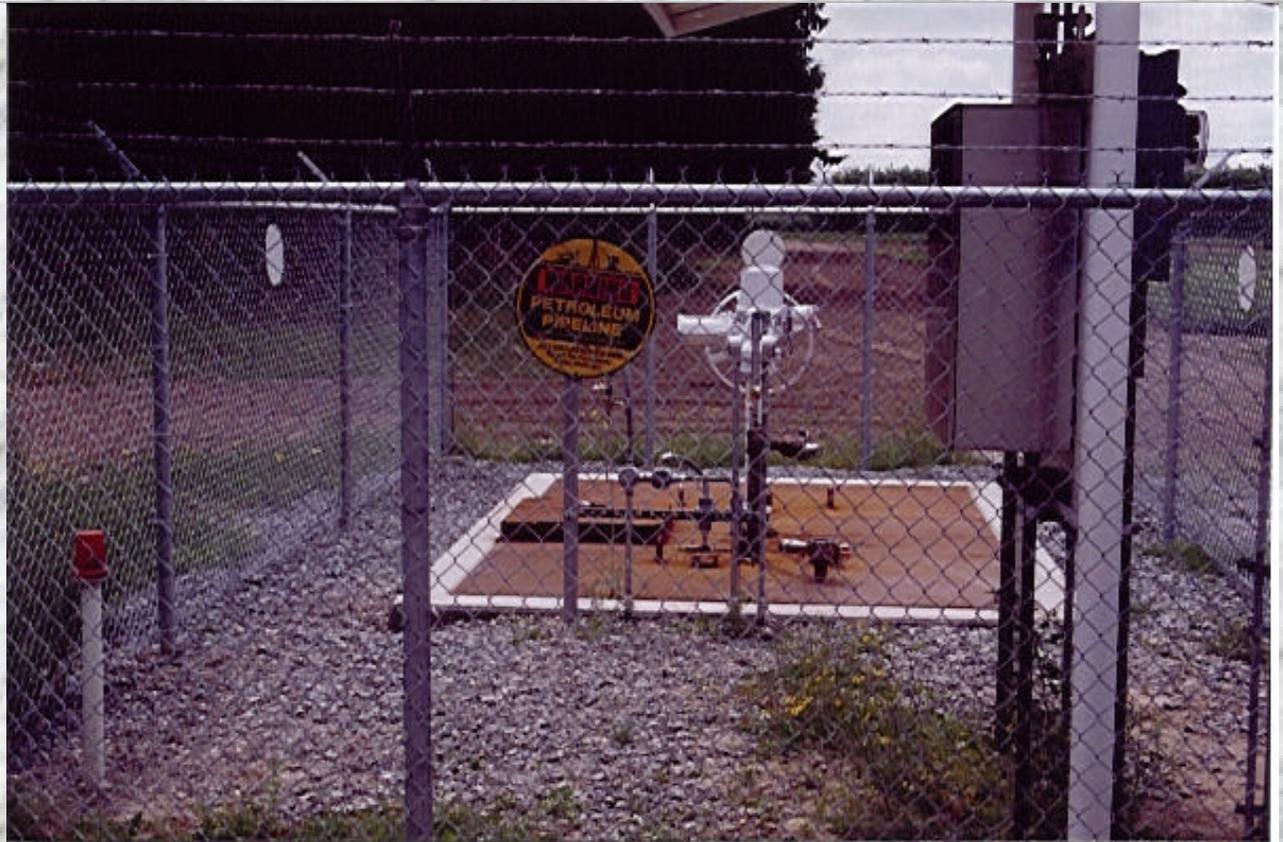
Remote
Control of
Existing
Valve at
MP 34
Samish
River

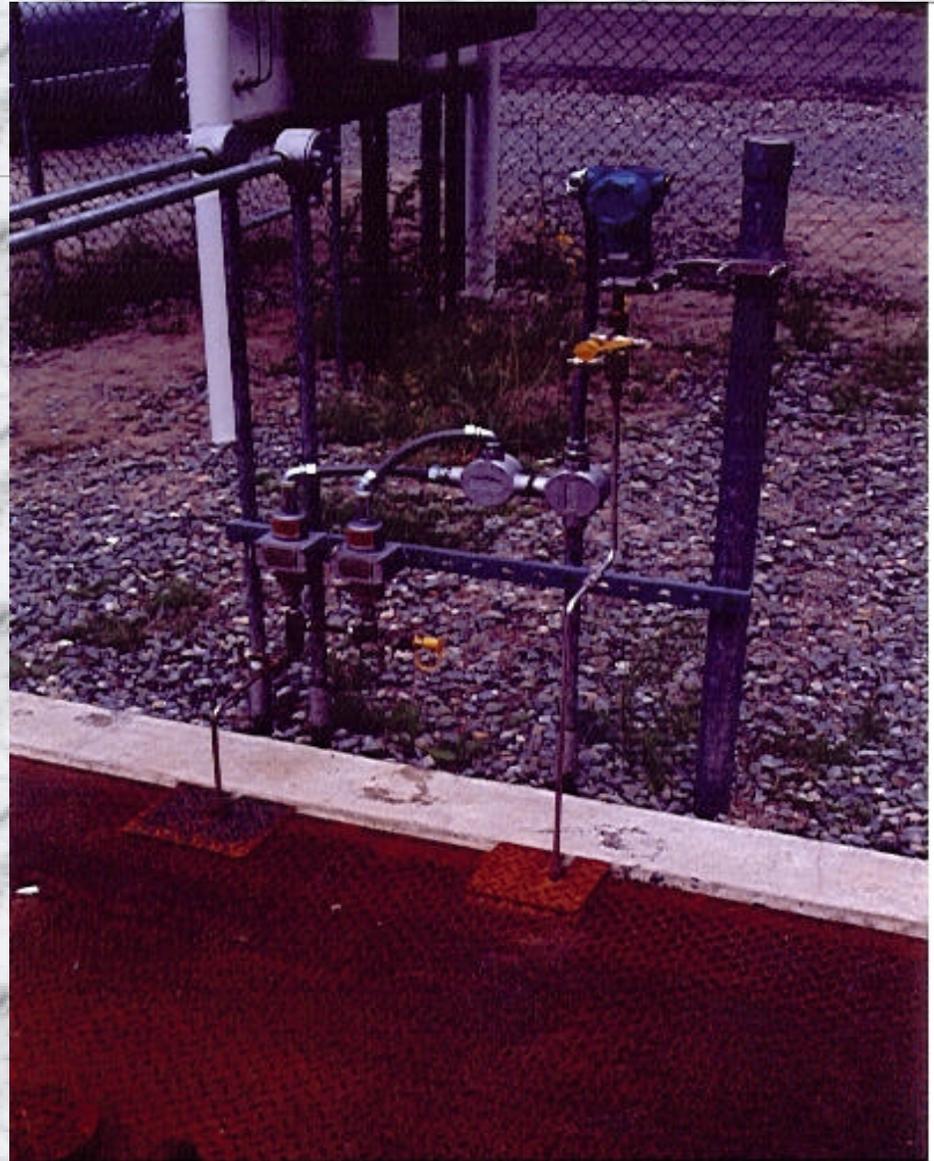
- Remote Control of Existing Valve at MP 34
- New Pressure Sensor and Overpressure Switches
